**State of California
The Resources Agency
DEPARTMENT OF WATER RESOURCES
Division of Flood Management**

**JUNE
2003
OFFICE REPORT**

**THE INSPECTION OF FLOOD CONTROL STRUCTURES
ON THE SACRAMENTO AND SAN JOAQUIN RIVERS
AND THEIR TRIBUTARIES**

**Prepared By The
Flood Operations Branch
FLOOD PROJECT INSPECTION SECTION**

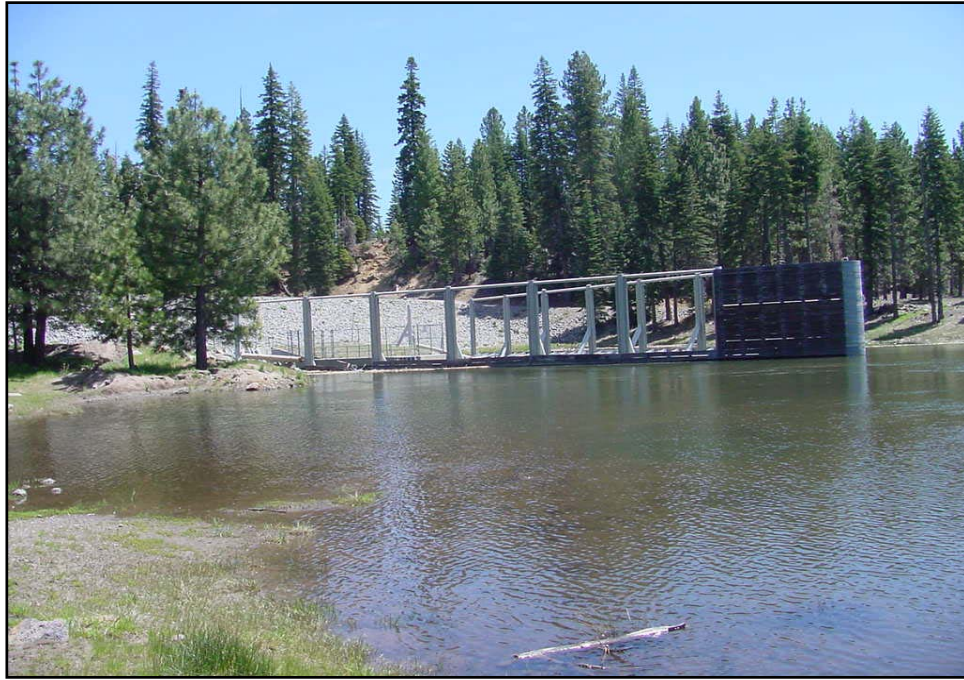
The upstream side of the diversion structure at the inlet.

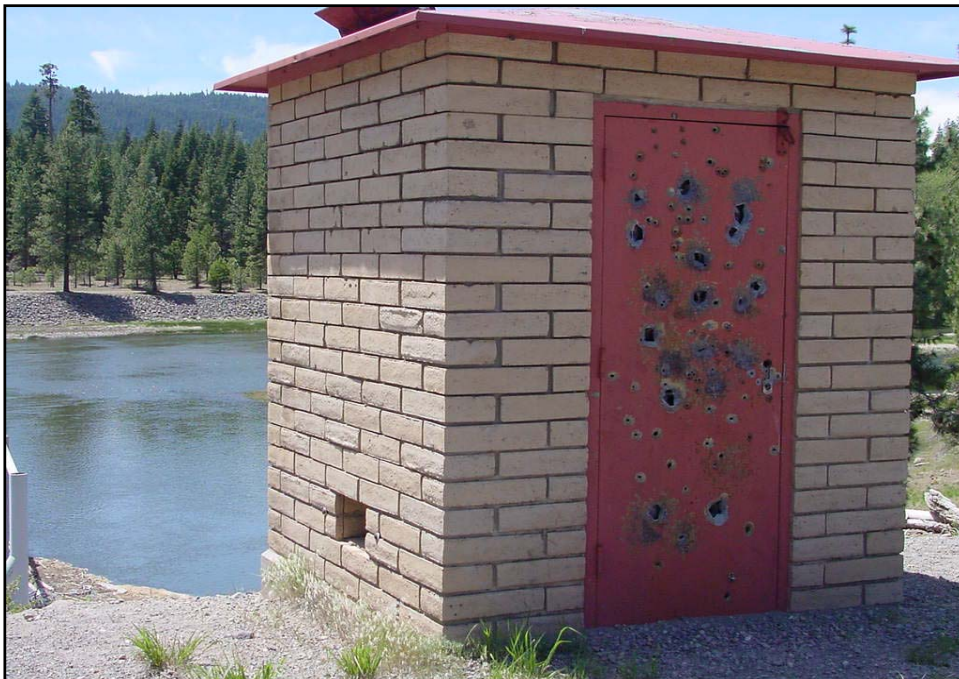
- 1. Condition of concrete diversion structure.**
 - a. Good.**
- 2. Condition of the gauging house and equipment.**
 - a. Fair. There are still numerous bullet holes in the door.**
- 3. Condition of the steel trash racks.**
 - a. Good.**
- 4. Condition of debris deflection structure.**
 - a. Good.**
- 5. Condition of the revetments.**
 - a. Good.**
- 6. Accumulation of trash and debris around structure or in the channel.**
 - a. Minimal amount of debris around the deflection structure.**
- 7. Vegetation around the structure or in the channel.**
 - a. None.**
- 8. Condition of the conduits.**
 - a. The center conduit was inspected last year and found to be in good condition. However, separation at the joints between the monoliths was noted.**

The gauging house door is severely damaged, resulting in no access.

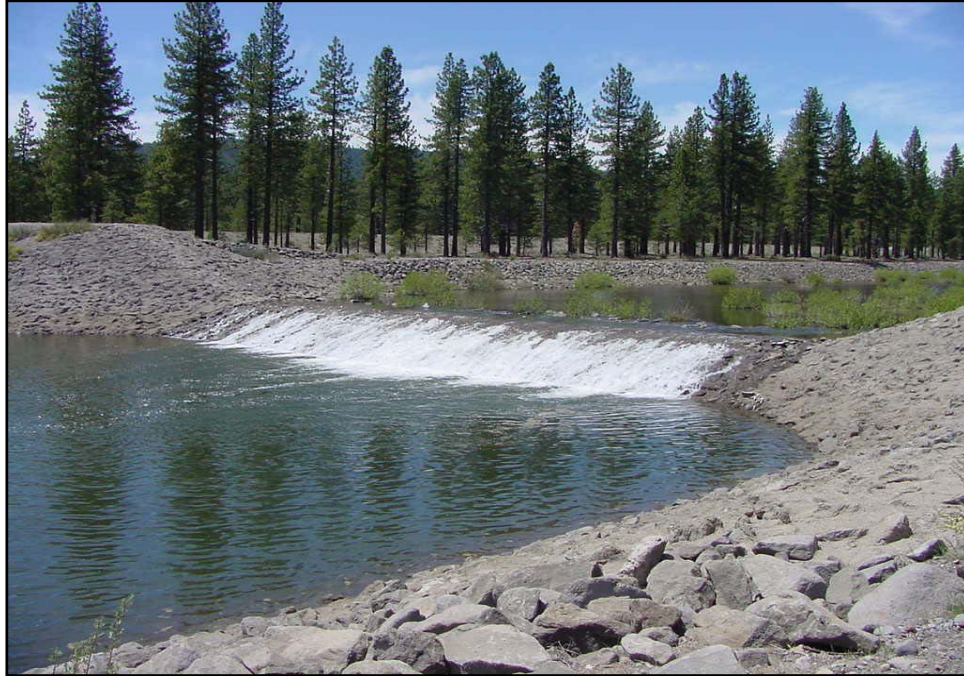
- 1. Condition of grouted rock revetment drop structures.**
 - a. Good.**
- 2. Condition of channel banks upstream and downstream of the drop structures.**
 - a. Good.**
- 3. Accumulation of trash and debris around the structures or in the channel.**
 - a. Minimal.**
- 4. Vegetation around the structures, the channel banks or in the channel.**
 - a. Minimal.**
- 5. Comments:**
 - a. Good maintenance.**

**View of Drop Structure No. 1 from the left bank.
Typical of all drop structures.**

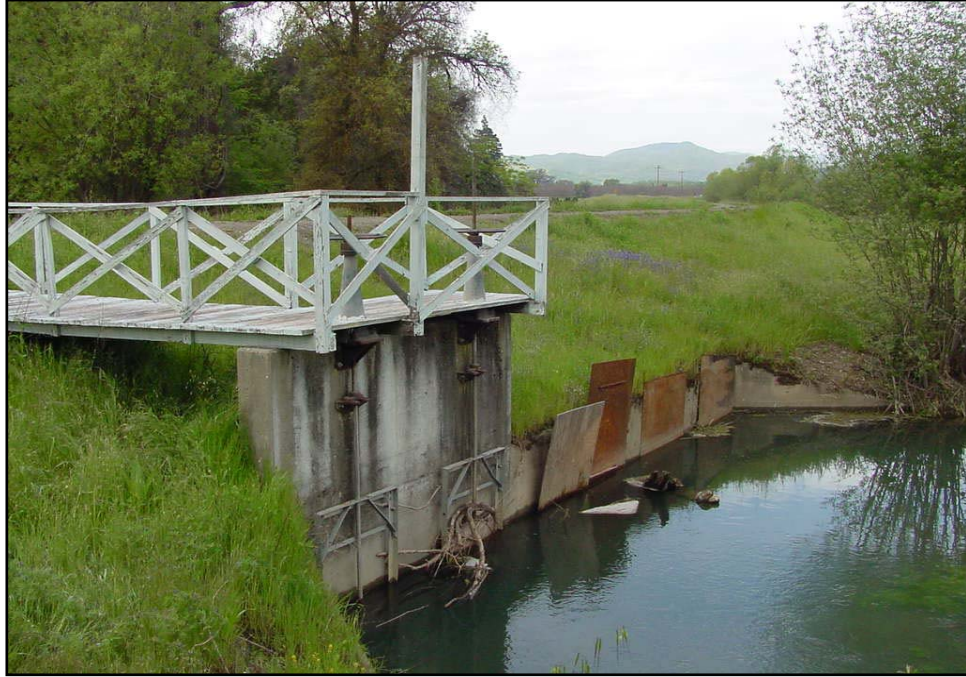
- 1. Condition of concrete weir structure.**
 - a. Good.**
- 2. Condition of the diversion structure and wing walls.**
 - a. Good.**
- 3. Condition of the bulkhead.**
 - a. Good.**
- 4. Condition of the control gates and mechanism.**
 - a. Good.**
- 5. Accumulation of trash and debris around the structures or in the channel.**
 - a. Gravel has accumulated and fills the channel to the top of the weir, this prevents water ponding upstream as it was designed to do.**
 - b. Some gravel has accumulated around the outlet side of the structure.**
- 6. Vegetation around the structures or in the channel.**
 - a. A pilot channel has been cleared upstream of the structure.**
 - b. There is dense vegetation in the creek channel, 100 feet downstream of the structure.**
- 7. Comments:**
 - a. Remove accumulated gravel upstream of weir.**
 - b. Good maintenance.**

Looking at the slide gates at the intake of the structure.

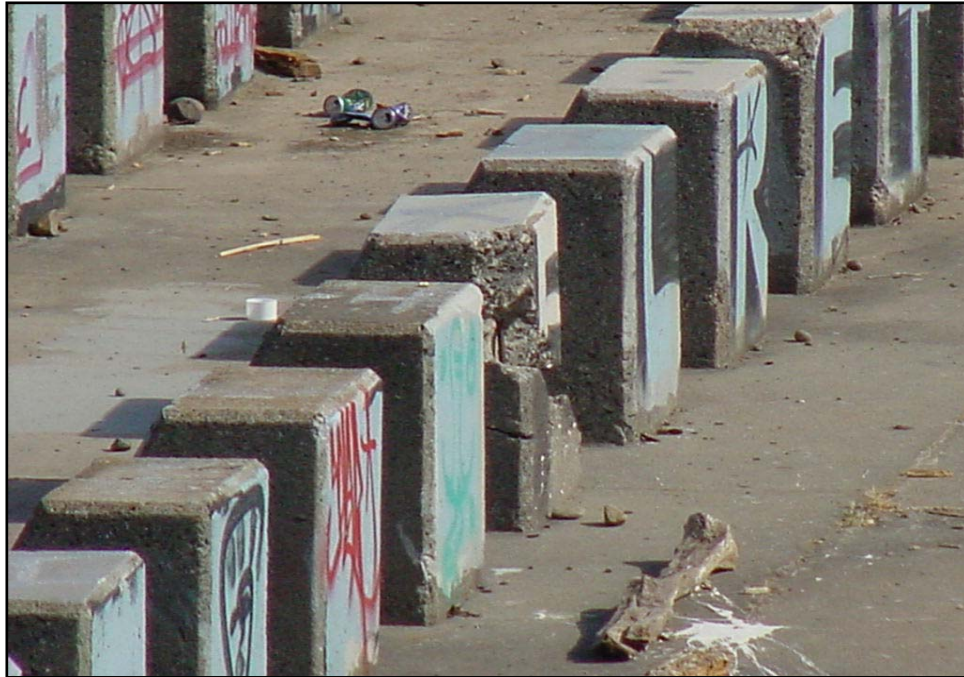
1. **Condition of concrete weir structure and stilling basin, and velocity dissipaters.**
 - a. **There are minor joint separations on the north and south ends of the weir where it contacts the abutments.**
 - b. **There is minor damage to several velocity dissipaters and severe damage to one.**
2. **Condition of concrete abutments and wing walls.**
 - a. **Good.**
3. **Condition of revetment.**
 - a. **Good.**
4. **Accumulation of trash and debris around the structure or in the channel.**
 - a. **None.**
5. **Vegetation around structure or in the channel.**
 - a. **Minimal.**
6. **Condition of gauging house and equipment.**
 - a. **Fair.**
7. **Comments:**
 - a. **Repair the severely damaged velocity dissipater.**
 - b. **Remove vegetation from channel.**
 - c. **Fair maintenance.**

View of severely damaged velocity dissipater.

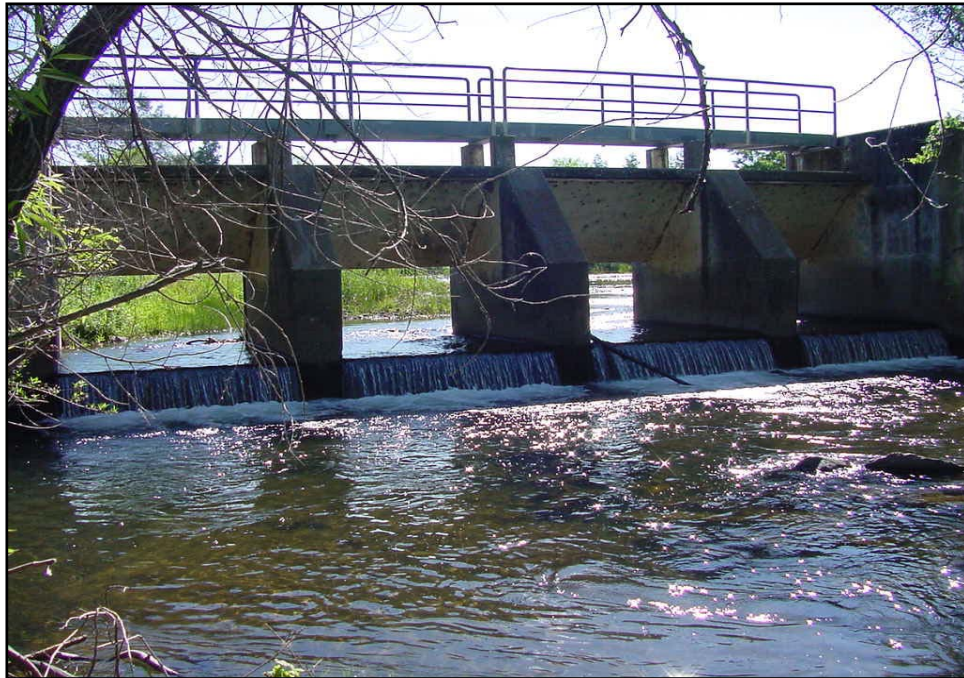
1. Condition of concrete control structure.
 - a. Fair. The base at the downstream side of the control structure is beginning to undermine.
2. Condition of bulkheads and wing walls of the control structure.

**Looking at the downstream side of the control structure.
Repairs have not been made to prevent undermining of the structure.**

- a. Repair the control structure base (downstream side) as soon as possible.**
- b. Continue to monitor joint separation between the control structure and the abutments and repair as needed.**
- c. Remove driftwood and cobbles from dissipaters.**
- d. Fair maintenance.**

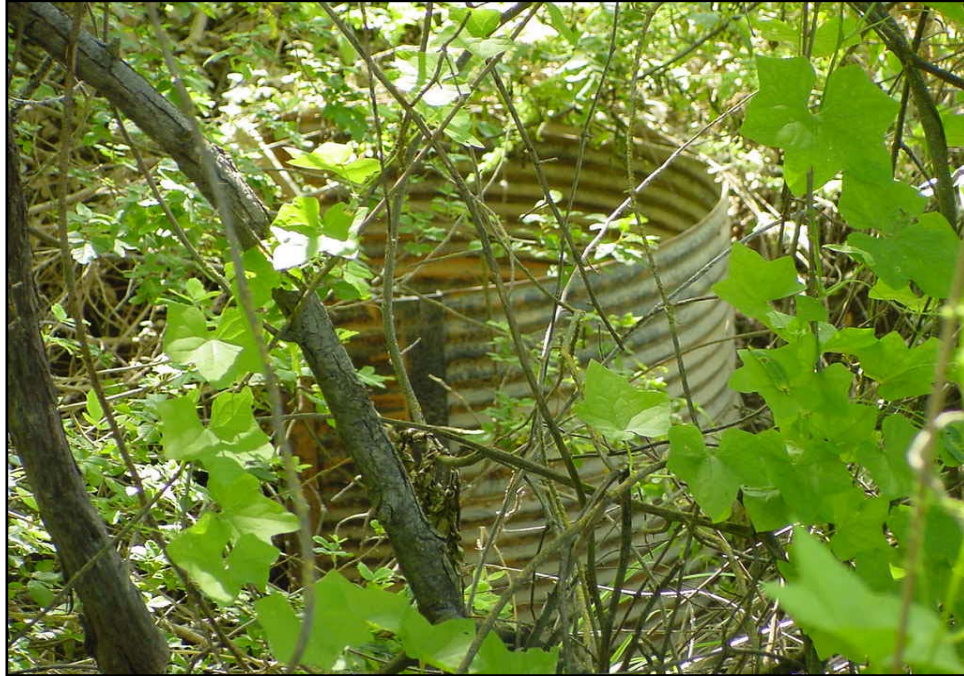
1. Condition of the corrugated metal pipe (CMP) drainage structure.
 - a. Good.
2. Condition of the control gate, mechanisms, and flap gates.
 - a. Could not properly inspect due to excessive vegetation.
3. Condition of the revetment.
 - a. Visual inspection was limited due to high water.
4. Accumulation of trash and debris around the inlet, in the pipe or in the channel.
 - a. Moderate.
5. Vegetation around the structure or in the channel.
 - a. Heavy vegetation around structure. Growth is so dense that the discharge side of the structure cannot be seen.
6. Comments:
 - a. Remove vegetation from inlet and discharge ends of structure. If growth is not removed, the drainage structure could become non functional.
 - b. No maintenance.
 - c. This structure is rated poor.

Looking at the inlet (CMP stand pipe) in the center of picture, obscured by heavy growth.

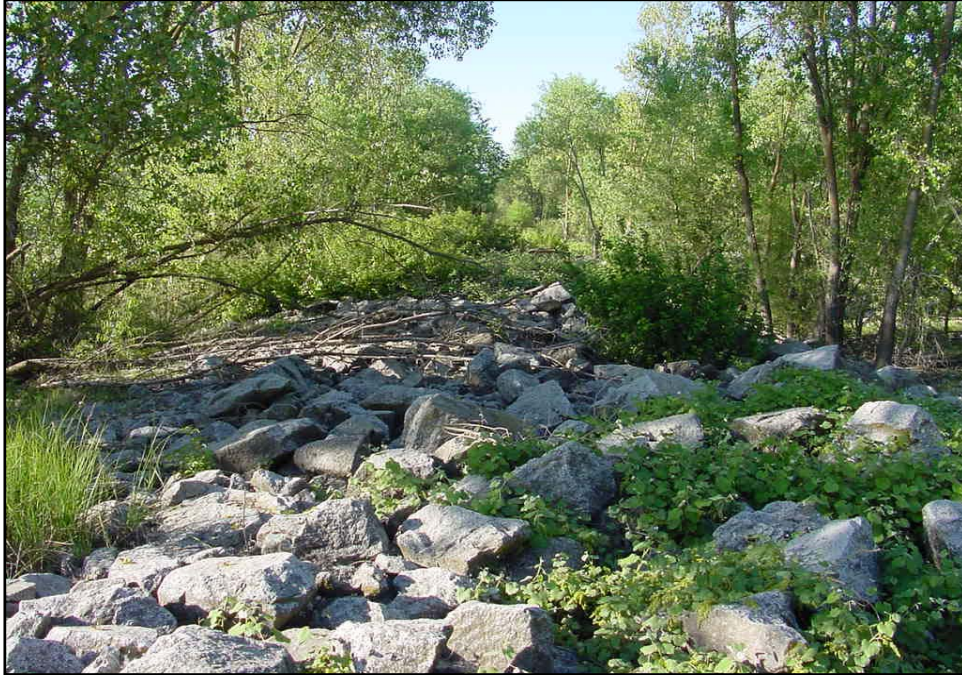
- 1. Condition of quarry rock weir section.**
 - a. Good.**
- 2. Condition of revetments.**
 - a. Good.**
- 3. Accumulation of trash and debris around structure or in the channel.**
 - a. Areas of debris exist along the weir and in the channel.**
- 4. Vegetation around structure or in the channel.**
 - a. Vegetation is very heavy, with trees, brush and berries growing in the weir section and rock revetments.**
- 5. Comments:**
 - a. No clearing done since 1985. The vegetation is extremely dense and could effect the design function of the weir.**
 - b. Poor maintenance.**
 - C. An unauthorized barricade has been installed at each end of Nelson Bend rock weir. The Reclamation Boards' Encroachment Section is investigating.**

Looking southwest at the growth and debris on the rock weir.

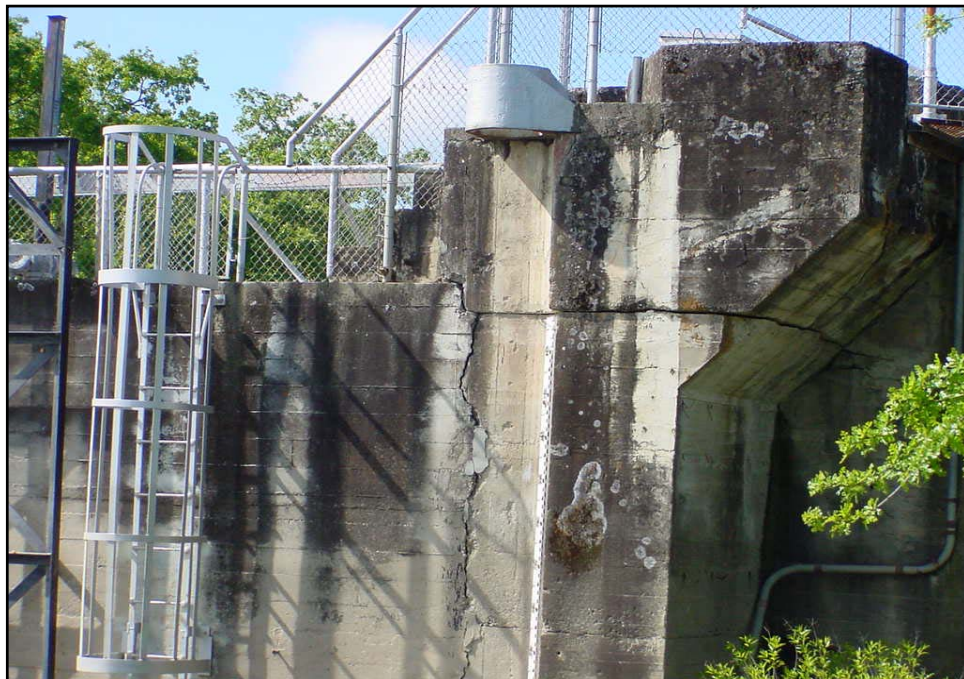
- 1. Condition of outfall structure.**
 - a. Good.**
- 2. Condition of bulkheads.**
 - a. Fair. The large vertical crack and displacement on the downstream side, left bank, has not changed in several years. The crack is not accessible for measurement, but the overall width is estimated to be one inch.**
 - b. The concrete construction joint between the left bulkhead and the outfall structure, upstream side, passes water when the Sacramento River is at high stage. Passage of water was first noticed in 1980.**
- 3. Condition of the pipes.**
 - a. Good.**
- 4. Condition of the control gates, mechanisms, and flap gates.**
 - a. Good.**
- 5. Condition of electrical equipment.**
 - a. Good.**
- 6. Condition of the gauging house and equipment.**
 - a. Good.**
- 7. Condition of the log boom.**
 - a. Good**
- 8. Condition of fill from bulkheads to levee.**
 - a. Good.**

There is a vertical crack and displacement on the downstream side of structure.

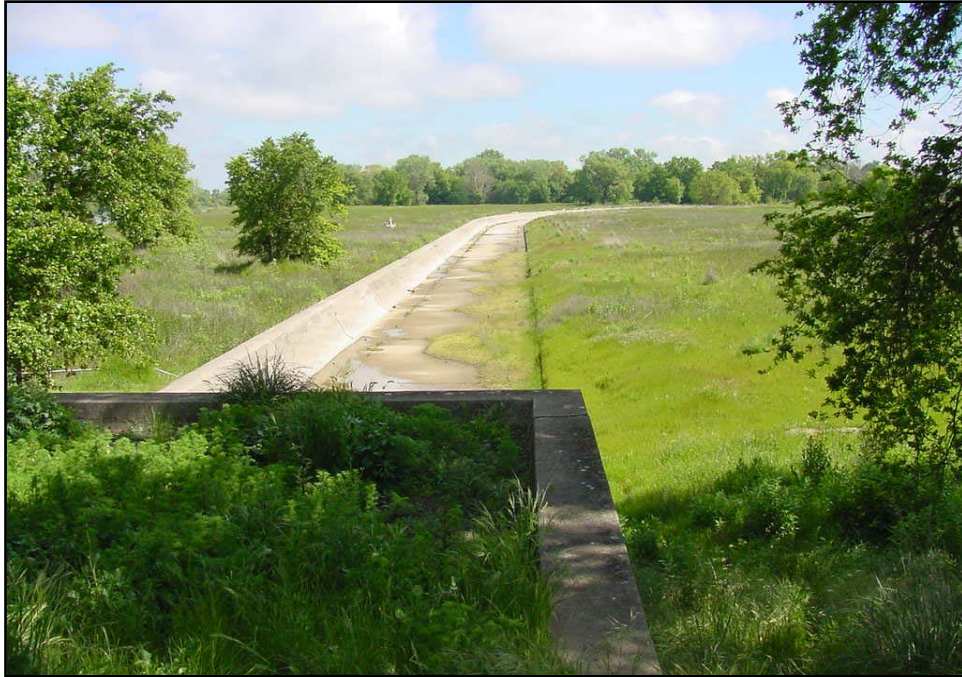
- 1. Condition of concrete weir and stilling basin.**
 - a. Some cracks and spalling exist on the weir and in the stilling basin as previously reported.**
- 2. Condition of concrete abutment.**
 - a. Good.**
 - b. The crack on the downstream side of the right (west) abutment, and the two cracks on the right abutment at Rattlesnake Island, have not enlarged.**
- 3. Condition of revetment.**
 - a. Good.**
- 4. Accumulation of trash and debris around the structure or in the channel.**
 - a. Minimal.**
- 5. Vegetation around the structure or in the channel.**
 - a. Minimal.**
- 6. Condition of gauging house and equipment.**
 - a. Good.**
- 7. Comments:**
 - a. Monitor the cracks and spalling, repair as needed.**
 - c. Remove debris from the stilling basin prior to flood season.**
 - c. Good maintenance.**

Looking south at the weir and stilling basin from the north abutment.

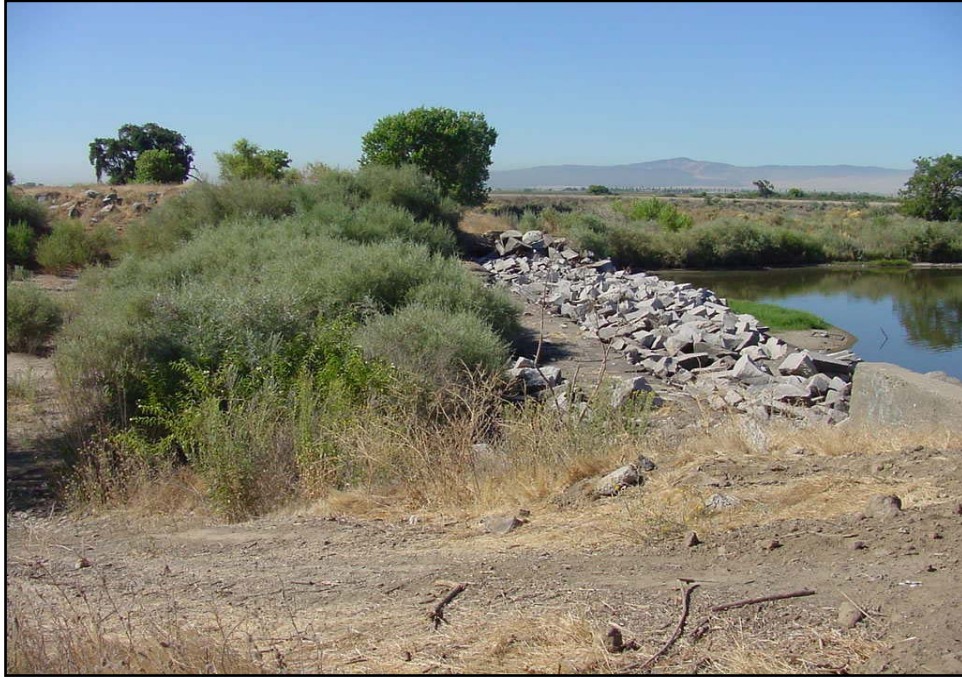
**Looking at the upstream side of the dam.
Note the willow growth in front of the structure.**

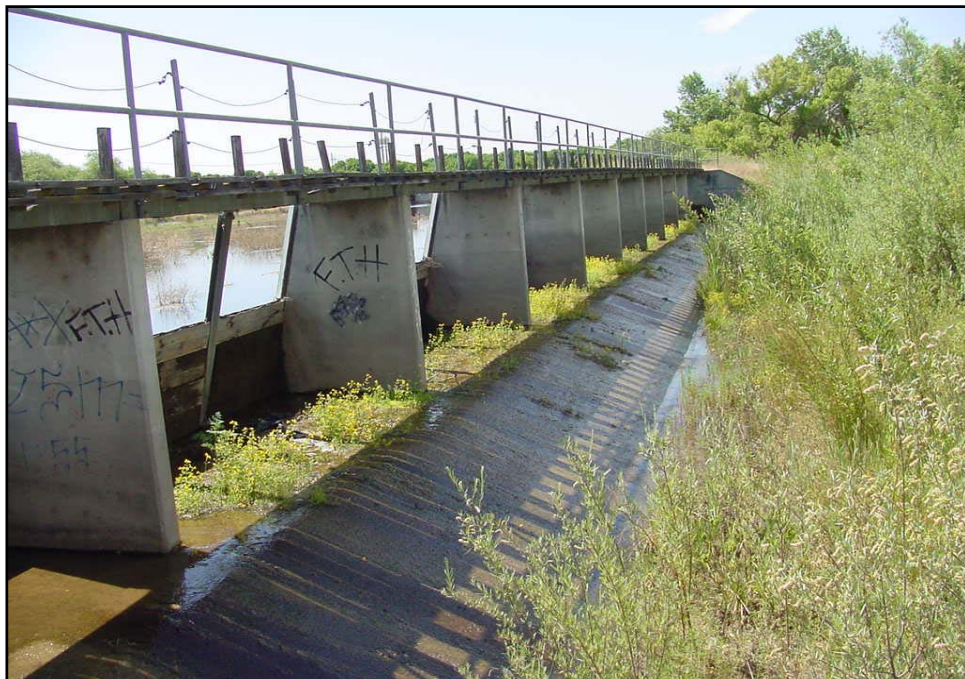
**Looking at the downstream side of the structure.
Note the dense vegetation in the downstream channel.**

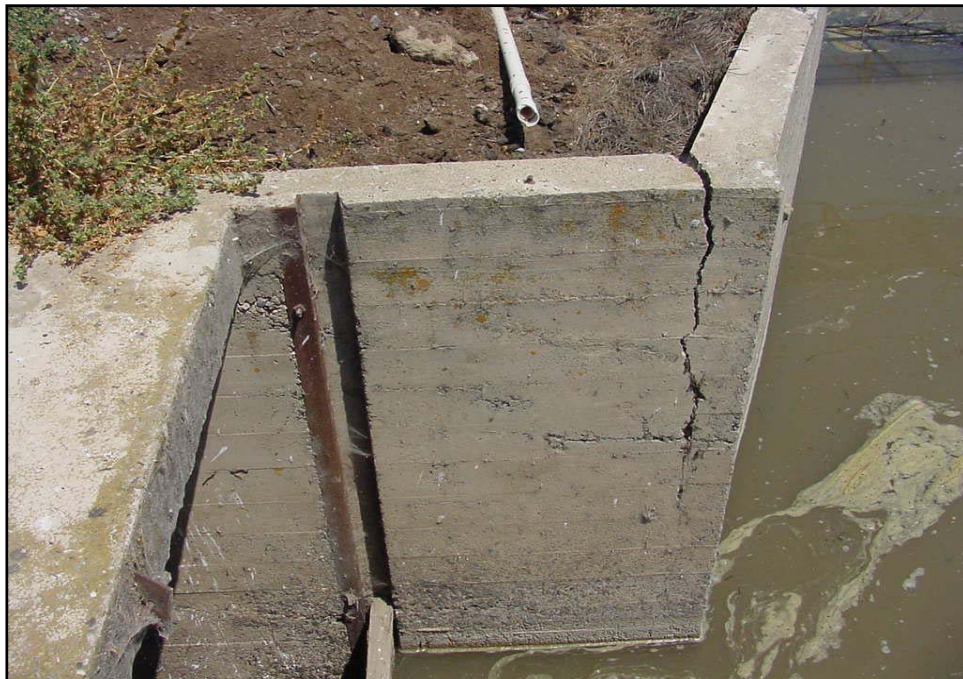
**Looking at the ½ inch crack in the right bank abutment
on the upstream side. The left bank abutment is also cracked.**

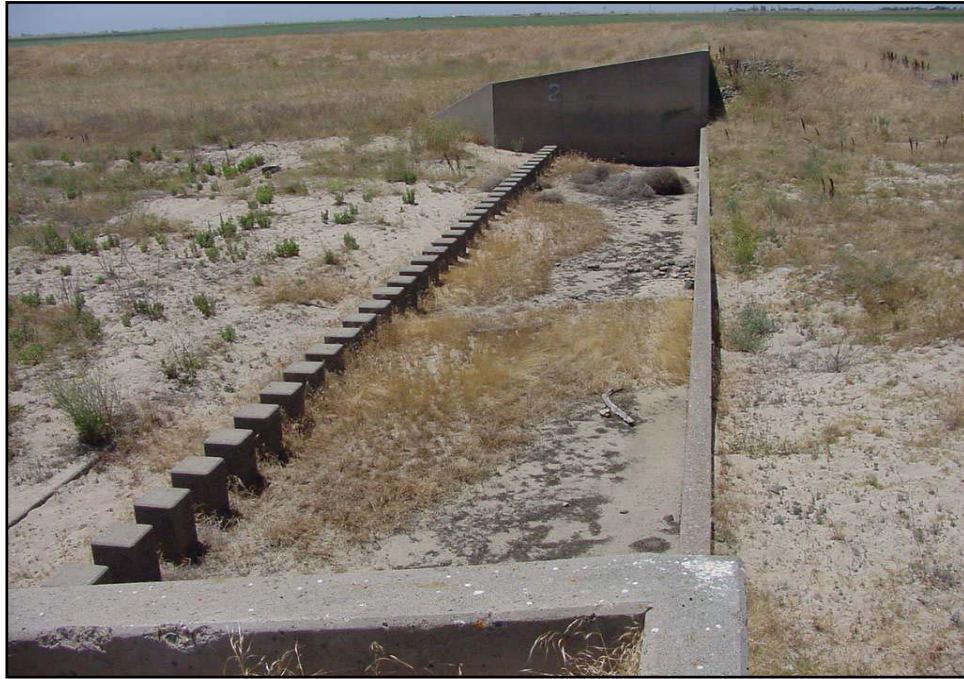
**Looking at the downstream side of the structure.
Sand is accumulating in the stilling basin.**
